### Smoke and Dye-Water Observation Summary

# Western Run Pilot Project - Baltimore Maryland

## **INSPECTION REPORT**

STREET: GLEN AVE. TEST 86 B 1 MAP #1: MH: 1521351 CITY: BALTIMORE MAP #2: MH: STUB MAIN RESIDENTIAL STREET LOCALE: TAPE #: JAM 2 TV'D LGTH: 28.37 ft

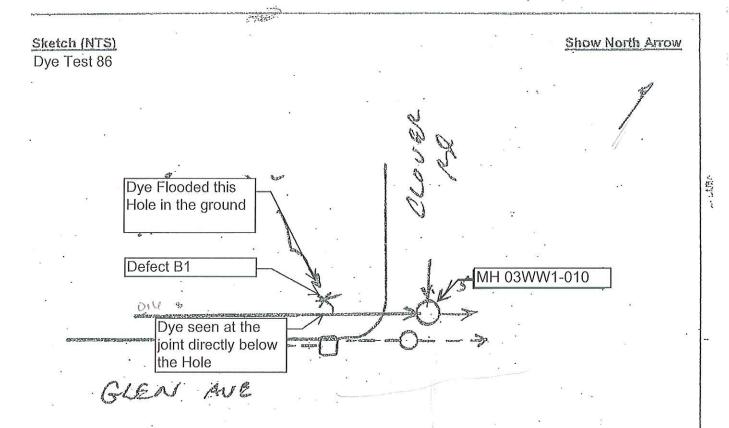
Englishing dodests		√ sati sesiikide	PARE RECHE	
1. POSITIVE	1. MAIN SEWER	5. DOWN SPOUT	9. STAIRWELL DRAI	13. STORM DRAIN
2. NEGATIVE	2. SERVICE LINE	6. DWNSPT CONN.	10. FOUNDATION DRAIN	14. CATCH BASIN
3. CANNOT TEST	3. TRANSITION JOIN .	7. AREA DRAIN	11. BUILDING INTERIOR	15. STORM MH
	4. CLEAN OUT	8. DRIVEWAY DRAIN	12. MH FRAME/SEAL	16. STORM DITCH
dditional Comments:	DYE SEE	N ATT 30	9/27, DI	RECTLY
BRLOW	i Hock	IN GRE	or us	<i>y</i>
			The second secon	
	A.J	dis Bretta
